WETLANDS ECOLOGY

A Village Within a Wetland:

A case study of the causeway which brought  
development to Crooked Tree

Gillian L. Hadley

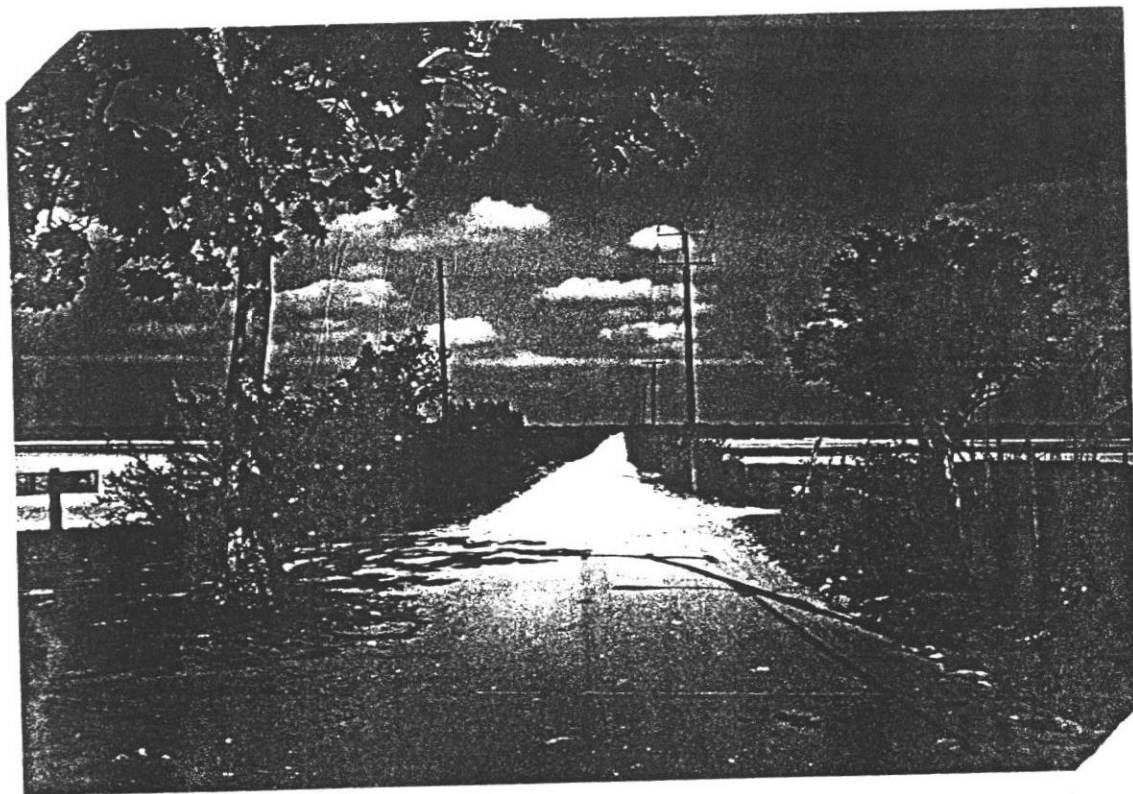
1A A view of the causeway from the intersection  
at the entrance to the village  
(North side is to the left)

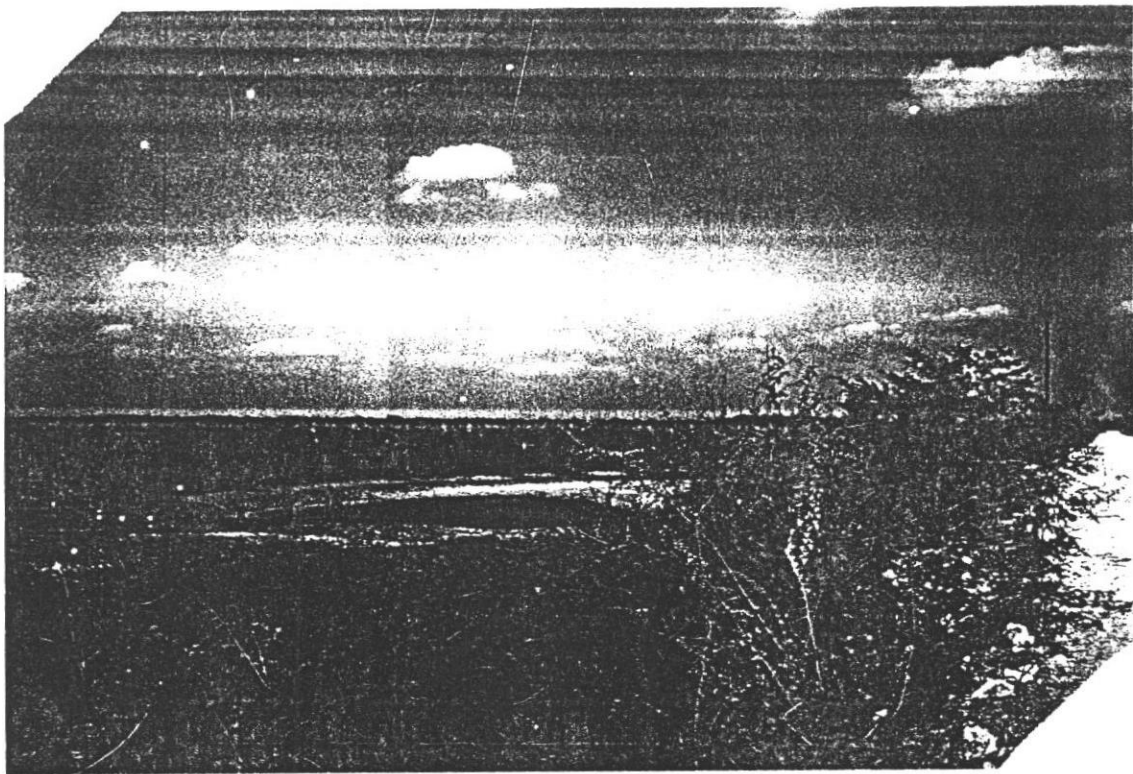
On the south side, the ground was cracked but not as dry, and there was more ground vegetation. The logwood trees were clearly flourishing and were much more developed and taller than their counterparts to the north, not having experienced the

[3A and 3B] The logwood stands on the south side (below) are more developed. There is also more ground vegetation showing than on the north side (above).

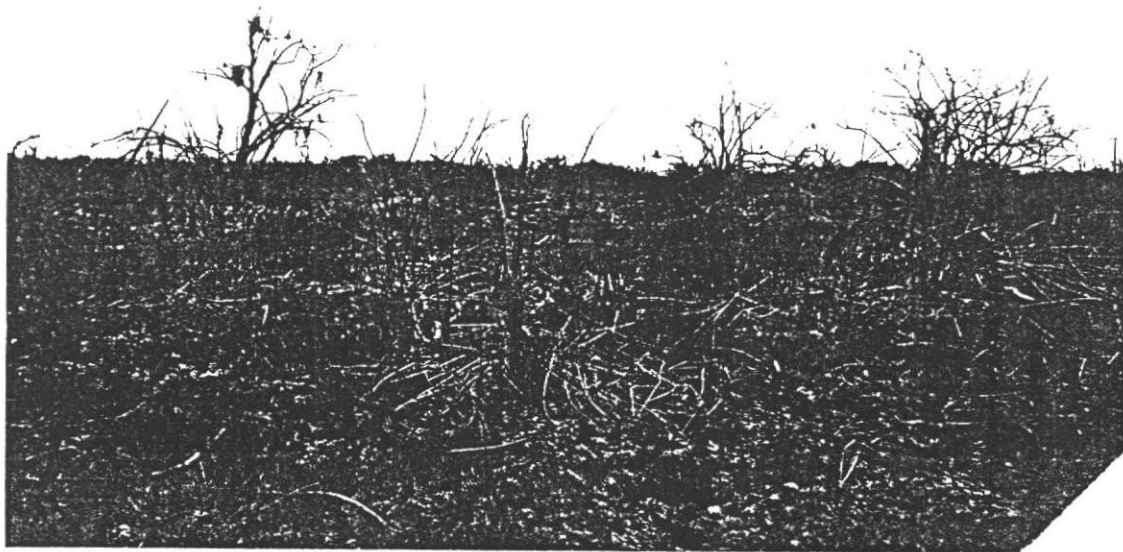
(4A and 4B) A closer look at the contrast between  
 vegetation north of the causeway (above) and south  
 of the causeway (below)

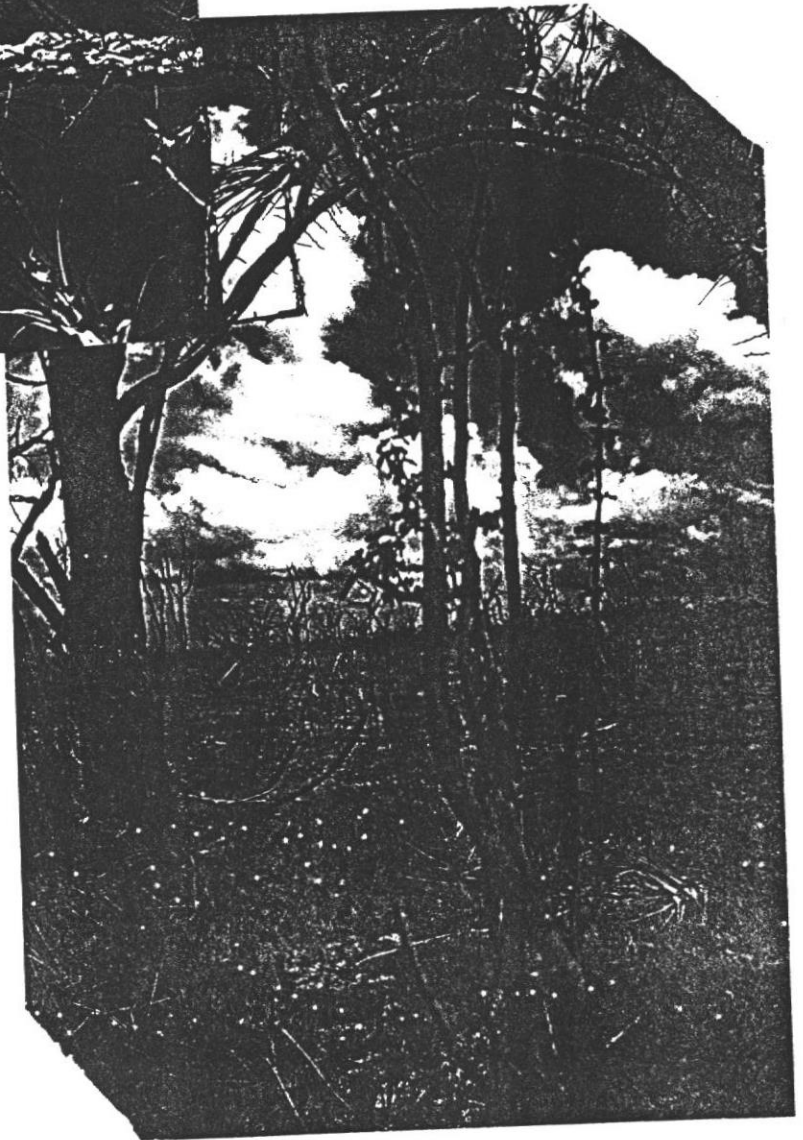
From these observations some conclusions could be drawn. The organic nature of the soil on the north side can be attributed to the build up of dead organic matter and subsequent decay of the logwood. Those logwood trees that still remain standing do not look as though they will make any sort of recovery. Other vegetation in the area still survives though, and with more time new communities will be established with new successional patterns which can function within the conditions present. With time, the two sides of the causeway will become more similar due to the equalizing effect of the flow now allowed under the causeway. When the conditions are right, perhaps logwoods will spread back over to the north side and begin to grow again. If the causeway proves to be too great of a barrier to allow this process to occur, artificial reforestation is another possibility. Logwood trees could be planted on the north side once the soil and water conditions were more equal to those on the south side.

5A and 5B Some signs of life  
on the north side. Left, a  
bromeliad growing on a dead  
logwood branch. Below, a live  
logwood brush plant.

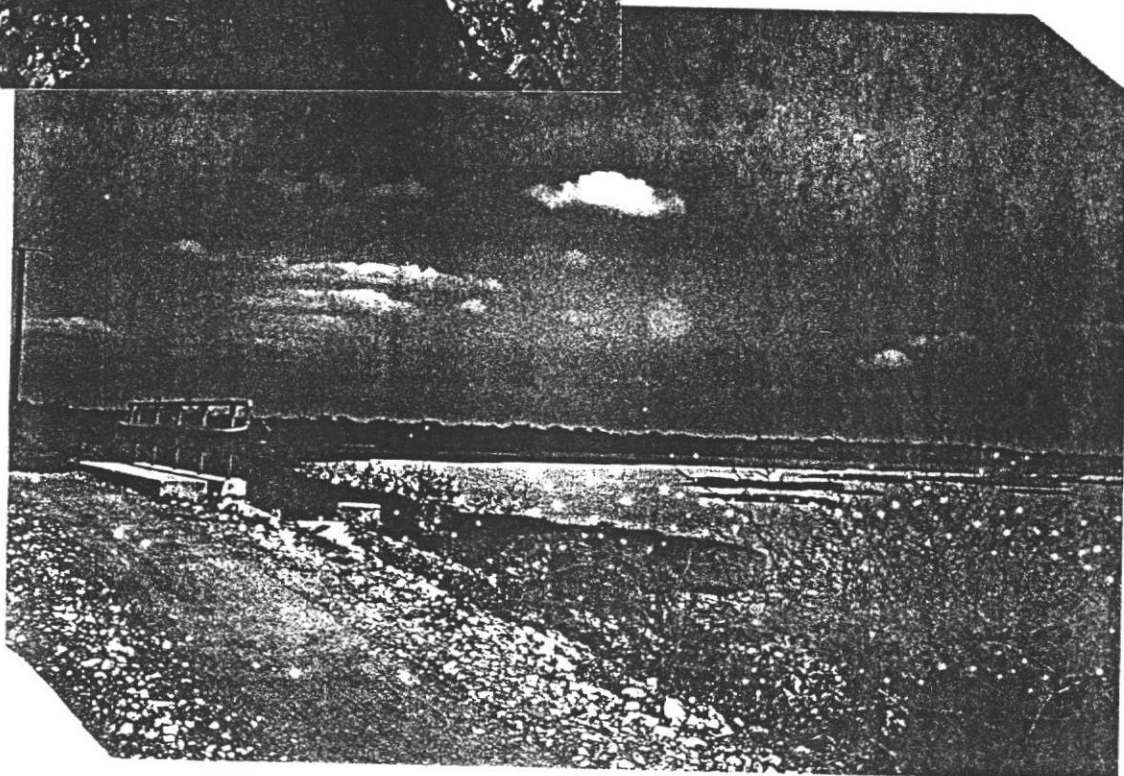
LoB (below)  
south of the causeway

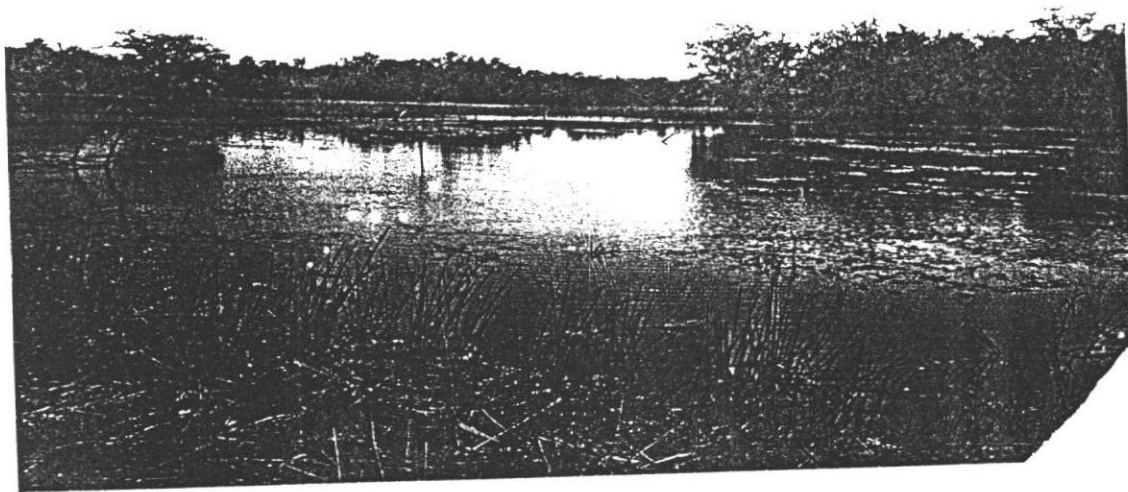
7A One of the "source ponds" found to the western side of the village. Retains more water in the dry season than the Crooked Tree (North) Lagoon.

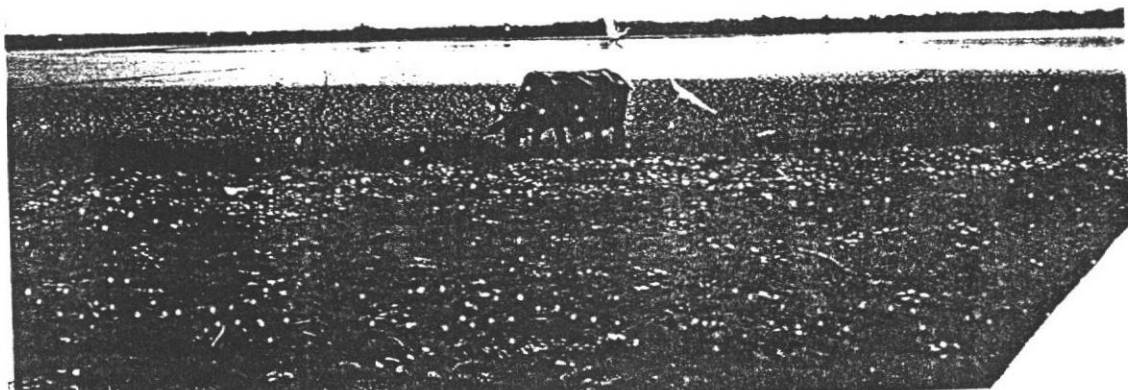
7B An illustration of one of the benefits of letting water levels decrease naturally - access to fertile grazing ground for horses and cattle.
